REPAIR TECHNOLOGY DEVELOPED BY AN INTERNATIONAL TEAM OF ENGINEERS

PROBLEM

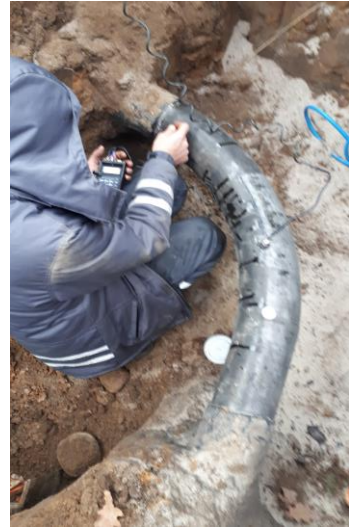
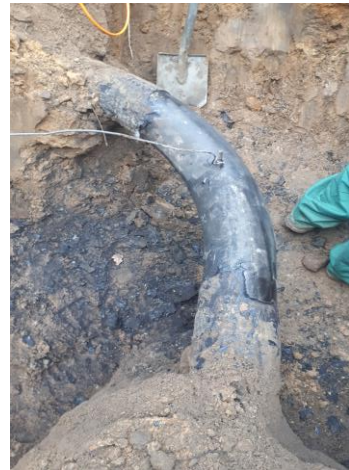
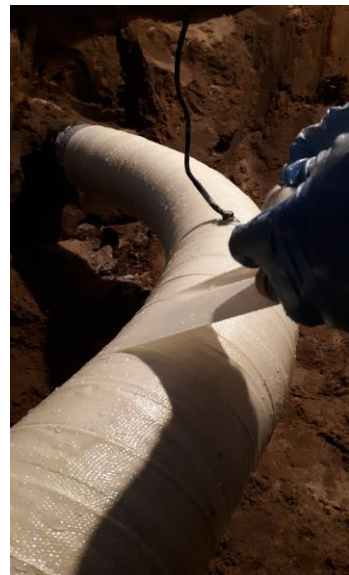
Operators of natural gas pipelines conduct regular inspections of the technical condition of the infrastructure. The protocols, which are the result of the inspection, are then analyzed in order to select the technology for repairing the pipeline or replacing the section in question (cutting and welding). In the case in question, as a result of non-destructive testing of the pipeline, wall thinning worth 30% of the wall thickness was detected - internal corrosion on the bend of the pipeline with a diameter of DN160 mm within the weld occurring over a length of 300 mm.

After analyzing the protocols, the decision was made to use GC Wrap series composite materials to repair this defect. According to ISO 24817, the length of the repair muffle was calculated to be 300 mm and a thickness of eight layers. However, after exposing a section of the pipeline and conducting an additional test with an ultrasonic inspection instrument, it was found that the loss of wall thickness occurred along the entire length of the bend, i.e. a distance of about one meter. After consultation with the technical department of Gascontrol Polska sp. z o.o., a new calculation was made and the length of the muffle was changed to 1200 mm. Afterwards, sandblasting (surface preparation) was carried out and the application of composite repair materials proceeded. It is worth mentioning that the repair was carried out under very low temperature conditions (+2C). To ensure proper conditions for the application and polymerization of the composite materials, a tent was installed over the trench and the repaired section of the pipe was additionally heated using special mats.

In less than three hours, surface preparation (sandblasting) was performed and then the fiberglass repair muffle was threaded. Thanks to the use of reheating mats, the same day the following was threaded C50 grade tape insulation. The next morning, a poroscope test was performed and the repair was completed. The use of composite repair materials was the best repair option for the case, which further extended the life of the pipeline for 20 years.
