REPAIR TECHNOLOGY DEVELOPED BY AN INTERNATIONAL TEAM OF ENGINEERS

PROBLEM

The subject of repair at the Zinc Smelter in Miasteczko Slaskie was a natural gas leak located at a flanged connection with a diameter of 400 mm, which was located around the circumference of the connection.

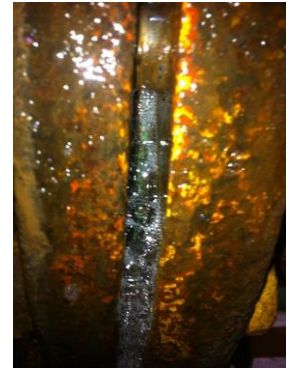
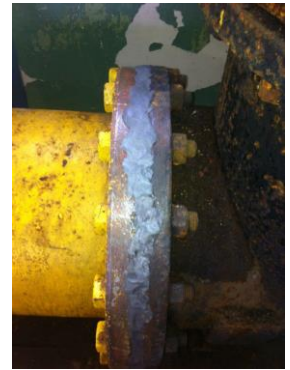
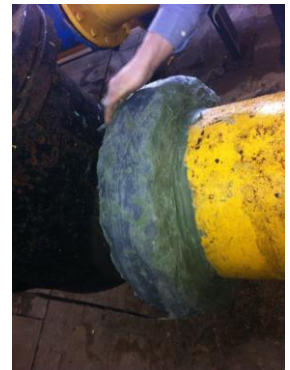
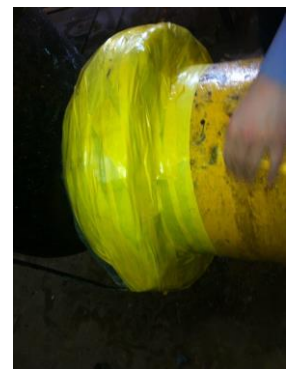
The pipeline was operating at a working pressure of 4 bars. The room where the leak was located belonged to a hazardous area, which is why there was no possibility of using any technology that could cause sparks (so-called hot work).

Gascontrol Polska sp. z o.o.'s team of specialists, trained to carry out repairs using composite materials in accordance with the ISO TS 24817 technical standard, decided to prepare the surface in the relief region using sandpaper. A two-component epoxy filler was then used to seal the surfaces between the flanges. A dynamometric wrench was also used to properly adjust the bolts – connecting the gate valve to the main pipeline.

After ensuring that the relief was closed (using a gas-analyzer), it was proceeded to protect the flange connection with a composite material made of urethane-soaked fiberglass, the use of which permanently protected the epoxy putty and allowed the flange connection to extend its service life by 10 years. Finally, the repair site was wrapped with petrolatum tape and UV isolation tape. The repair was completed in four hours by a team of three technicians working on site along with a supervisor.
