### REPAIR TECHNOLOGY DEVELOPED BY AN INTERNATIONAL TEAM OF ENGINEERS

### PROBLEM

### APPLIED SOLUTION

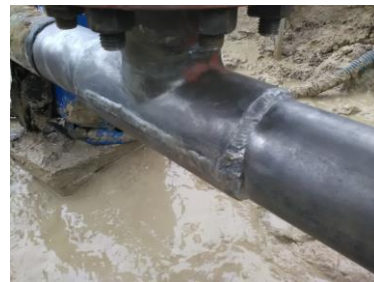
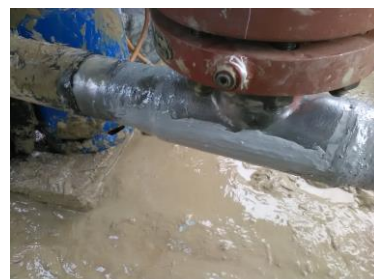
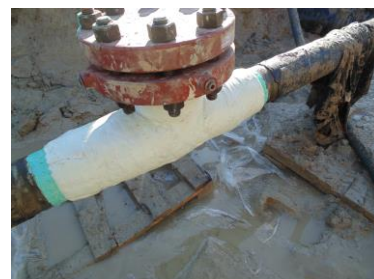
Weld degradation is a serious problem encountered in the daily operation of natural gas transmission pipelines. It is a problem that is difficult to repair, while in most cases repairs using welding are prevented due to the fact that the pipeline is operating under pressure, on the other hand, in most cases it is not possible to take the pipeline out of service. In repairs of such cases, composite materials come to the rescue. Gascontrol Polska sp. z o.o., thanks to the TUV certificate for the GC Wrap reinforcement system used and the approval of the repair technology by the UDT, can perform such repairs (supported by engineering calculations) on transmission pipelines operating at working pressures up to 10 MPa.

In the described case of the repair, the welds on a tee assembled on a pipeline with a diameter of DN150, operating at a working pressure of 3.5 MPa, had to be strengthened without taking the installation out of service. The repaired section of the pipeline was located on the territory of a reduction and measurement station in the Silesian province. Based on the pipeline inspection data, the degree of weld degradation was determined and the length of the repair was designed along with the number of layers. After surface preparation, an epoxy filler was applied for leveling and then the entire tee was wrapped with XX layers of urethane-saturated fiberglass material.

The use of composite repair materials made it possible to carry out the repair without taking the pipeline out of service. The repair performed in accordance with the ISO TS 24817 technical standard guarantees the extension of the pipeline's service life for up to 20 years. Gascontrol Polska sp. z o.o. has a team of qualified specialists and more than 50 completed applications for repairs with composite materials.
