REPAIR TECHNOLOGY DEVELOPED BY AN INTERNATIONAL TEAM OF ENGINEERS

PROBLEM

APPLIED SOLUTION

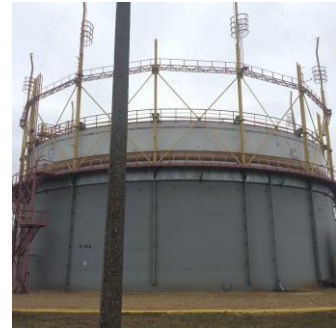
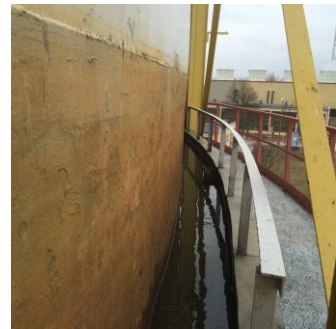
Composite materials are not only a repair solution when used to wrap pipelines for transmission of fuels and liquids. Fiberglass and carbon fiber soaked with epoxy can also be used as patches on flat surfaces. A good example of such an application is the repair performed at a gas storage facility in Odolanów. The user of the warehouse detected numerous reliefs on the external surface (mainly on welded joints). The task was difficult, because in this case there was no question of taking the installation out of service and, in addition, the repaired surfaces are above or below water, depending on how full the warehouse is with natural gas.

After analyzing the condition of the external surfaces (corroded state) of the gas tank, it was decided to prepare the surfaces in the regions of the reliefs using Monti's sparkless tool, then seal the surfaces with a two-component epoxy filler of liquid consistency. The final step was the application of the composite material - fiberglass soaked in epoxy, to the previously prepared surface. The size of each patch and the number of layers to be applied was calculated in advance by Gascontrol Polska engineers in accordance with the principles of the ISO 24817 technical standard.

Thanks to the efficient work of a team of technicians from Gascontrol Polska sp. z o.o., more than 20 reliefs were identified and removed on the surface of the tank, which is a natural gas storage facility. The work was carried out within two weeks, and was conditioned by the level of the tank's emergence. The repairs allowed the gas storage facility to extend its service life by 20 years, according to ISO TS 24817.
