REPAIR TECHNOLOGY DEVELOPED BY AN INTERNATIONAL TEAM OF ENGINEERS

PROBLEM

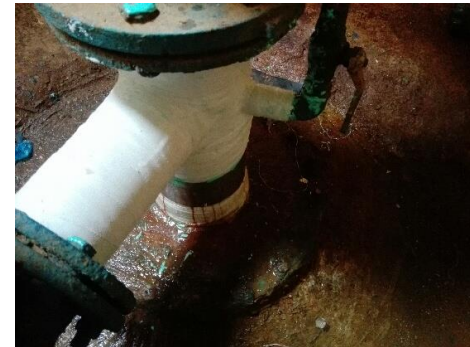
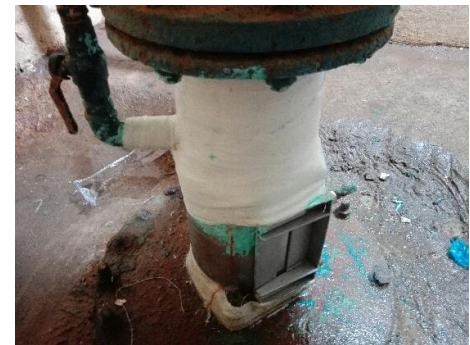
Composite repair materials are an effective repair method not only for gas pipelines. They are ideal for repairing all kinds of pipelines made of steel, cast iron or PVC. In the case described here, the repair involved a water leak on a tee, which worked as part of an artesian well installation - a working pressure of 4 bar. The repair was located inside an underground bunker at a depth of about 2 meters. An additional difficulty was the inability to take the water supply out of service and the high humidity inside the bunker.

Called to the site of the leak, a team of specialists from Gascontrol Polska sp. z o.o. first closed the leak using a two-component epoxy putty and special rubber tape. Then, after preparing the appropriate surface profile, epoxy primer was used and finally the entire tee was wrapped with urethane-soaked fiberglass material. An important point in the selection of the material was the fact that the fiberglass material is activated with water and moisture from the air. This is the only factor necessary during the activation and hardening of the composite system.

Thanks to the use of composite repair materials, the leak could be repaired without taking the installation out of service. All work was carried out by two pre-trained specialists from Gascontrol Polska sp. z o.o. in less than two hours. The use of modern repair technology extended the life of the pipeline by 10 years.
