REPAIR TECHNOLOGY DEVELOPED BY AN INTERNATIONAL TEAM OF ENGINEERS

APPLIED SOLUTION

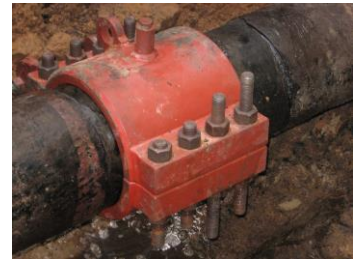
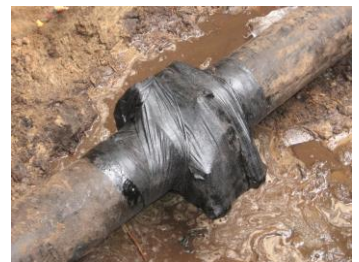
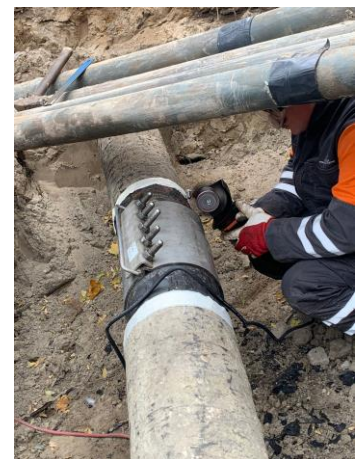
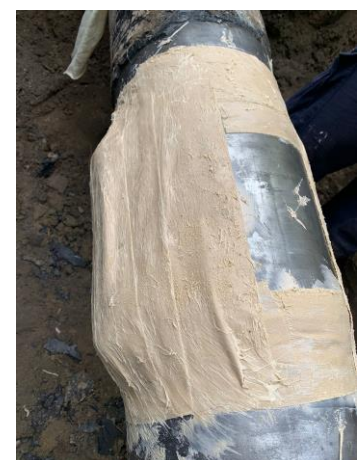
In practice, it is very common that after the relief of gas is closed with a steel clamp or repair band on the gas transmission pipeline - the repair site is buried without the required corrosion protection of the pipeline section, along with the band or clamp itself. It is also common to see applications of the anti-corrosion tape itself - made directly to the clamp or band - made incorrectly. These applications unfortunately do not protect the repair site in any way. The irregular shape of the band itself, along with the bolted connections, makes this an area that needs to be insulated using appropriate materials. Although this application must be carried out in several stages, it is a necessary action to maintain the integrity of the isolation on the transmission pipeline.

In the case described here, permanent corrosion protection was carried out on a steel repair band placed on a DN250 mm diameter transmission pipeline to close off natural gas relief. First, the existing isolation on the pipeline was removed at a distance of 100 mm on each side of the repair band. Afterwards, surface preparation was carried out using a MONTI Bristle Blaster brush grinder. The irregularities of the clamp and the transition between the clamp and the pipeline were protected with an anti-corrosion material (compound and petrolatum tape) of A30 class. HSEP epoxy primer was applied to the surface so prepared, followed by four layers of GC HYDRO WRAP composite repair bandage. Finally, C50 grade anti-corrosion tape was wound over the entire repaired length.

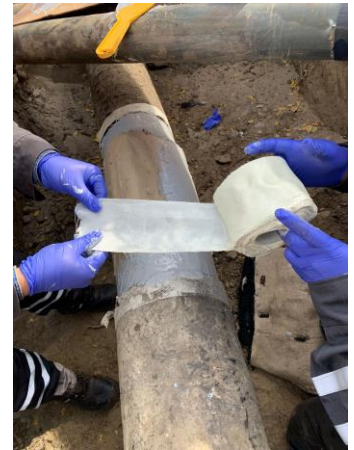
In the case described here, materials which were used, firstly, made it possible to compensate for the irregular shape of the clamp together with the fittings (A30 grade mass and anti-corrosion tape), and secondly, a durable coating with high hardness was created thanks to the use of GC HYDRO WRAP water-activated composite material. The use of composite technology on transmission pipelines is long-term (the life of the repair according to PN EN ISO 24817 is 20 years). It allows to obtain not only structural reinforcement of the repaired pipeline section, but also an abrasion-resistant coating with high hardness (>74 on the SHORE D scale). A section of the pipeline with regular round shapes protected in this way can be properly protected with C50 class tape isolation.
