REPAIR TECHNOLOGY DEVELOPED BY AN INTERNATIONAL TEAM OF ENGINEERS

PROBLEM

APPLIED SOLUTION

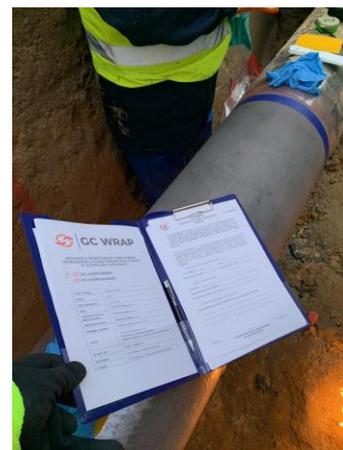
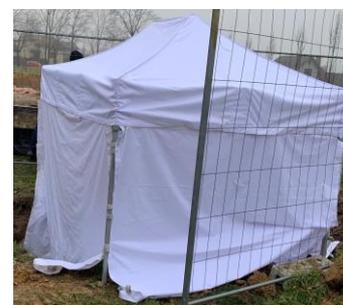
Pipelines are much more likely than gas pipelines to experience internal corrosion. In the case of internal corrosion, it is necessary to design a repair solution based on the inspection protocol and each time agree with the operator on the time for which the repair is designed. Since composite materials are always applied on the outside of the pipeline, the longer the service life, the longer the length of the repair muffle. The application of composite materials is a process that is controlled from start to finish, and all its steps are recorded and then approved. According to PN EN ISO24817, in addition to the engineering calculations that are made each time for a particular repair, it is important to ensure that a validation protocol is always completed during the installation process.

Based on the study drawn up following the pipeline pumping, the operator ordered the repair of two internal corrosion defects on an oil pipeline with a diameter of DN350. Gascontrol Polska sp. z o.o. engineers carried out calculations based on which a composite repair muffle was designed. The material used is GCWrap, which is made of fiberglass. Its installation is very simple because it only requires using a two-component primer and then activating the bandage with water. Due to the low ambient temperature, a tent was set up at the repair site. This resulted in the right temperature - +15C, which ensured quick polymerization of the materials. Applying eight layers of the material over a length of 400 mm took the trained specialists about two hours.

The use of composites made it possible to perform the repair without taking the pipeline out of service. Later the same day, C50 grade tape insulation was wound over the hardened coating of the composite material, completing the repair. All data on the renovation was recorded in the repair validation protocol, which was included in the as-built documentation.
