REPAIR TECHNOLOGY DEVELOPED BY AN INTERNATIONAL TEAM OF ENGINEERS

PROBLEM

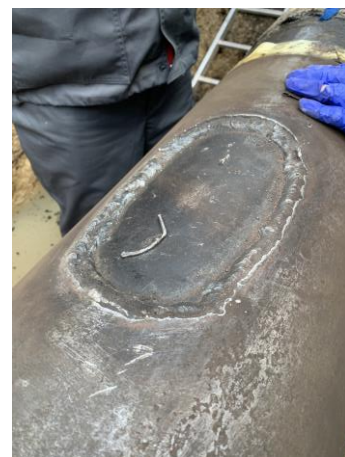
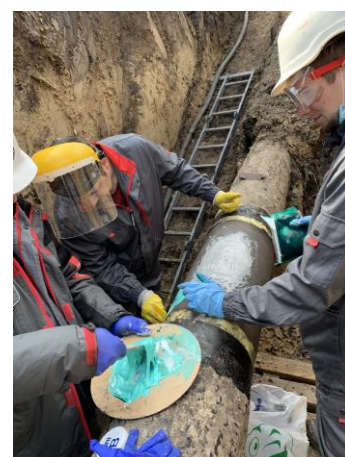
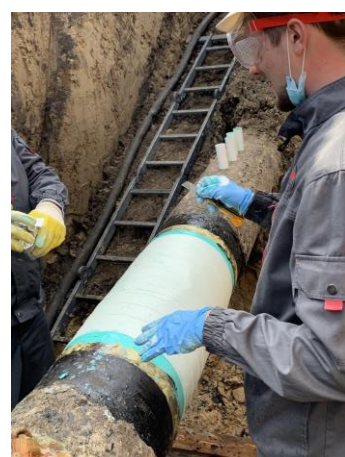
Gascontrol Polska sp. z o.o. not only carries out pipeline repairs with composite materials on its own, but also provides services: training for other companies in the installation of composites and supervision of such work (supervising). In the case in question, the repair concerned a defect located on the Kiev-Kursk (Ukrainian territory) gas pipeline with a diameter of 325 mm, operating at a working pressure of 35 bar. The defect is a 40 x 250 mm steel patch welded on the inside to the pipeline wall.

After consulting with the engineering department of Gascontrol Polska sp. z o.o. regarding the proper protection of the defect in issue, the length of the repair was estimated at 600 mm and the number of layers of composite material at 18 layers. Urethane-soaked fiberglass was used as the material. The repair work began with the removal of isolation, then the surface was cleaned with spark-free brushes. The entire surface of the patch was filled with an epoxy compound - filler, then an adhesion-enhancing primer was used, and the entire length of the repair was wrapped with 18 layers of composite material.

Thanks to the presence on site of a supervisor from Gascontrol Polska sp. z o.o., who trained installers from a local pipeline maintenance company and supervised the repair work, the repair was completed in three hours (including the time required for removal of isolation and surface preparation). The repair was carried out without taking the pipeline out of service. The service life of the pipeline could be extended by 20 years in accordance with the ISO TS 24817 technical standard
