REPAIR TECHNOLOGY DEVELOPED BY AN INTERNATIONAL TEAM OF ENGINEERS

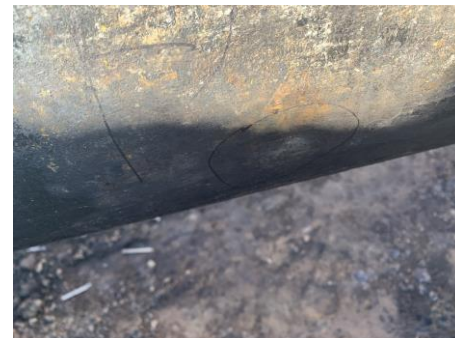
Gascontrol Polska sp. z o.o. not only carries out pipeline repairs with composite materials on its own, but also provides services: training for other companies in the installation of composites and supervision of such work (supervising). In the case in question, the repair concerned a defect located on the Kiev-Kursk (Ukrainian territory) gas pipeline with a diameter of 325 mm, operating at a working pressure of 35 bar. The defect is a dent in the outer wall of the pipeline with a maximum depth of 5 mm.
