REPAIR TECHNOLOGY DEVELOPED BY AN INTERNATIONAL TEAM OF ENGINEERS

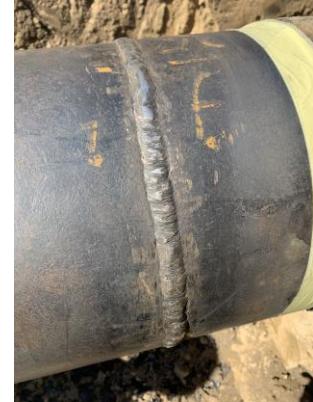
Gascontrol Polska sp. z o.o. not only carries out pipeline repairs with composite materials on its own, but also provides services: training for other companies in the installation of composites and supervision of such work (supervising). In the case in issue, the repair concerned the degradation of the welded joint of two sections of the 325 mm diameter Kiev-Kursk (Ukrainian territory) gas pipeline, operating at an operational pressure of 35 bar. The defect was revealed during the inspection of the pipeline with an MFL piston.
