### REPAIR TECHNOLOGY DEVELOPED BY AN INTERNATIONAL TEAM OF ENGINEERS

### PROBLEM

### APPLIED SOLUTION

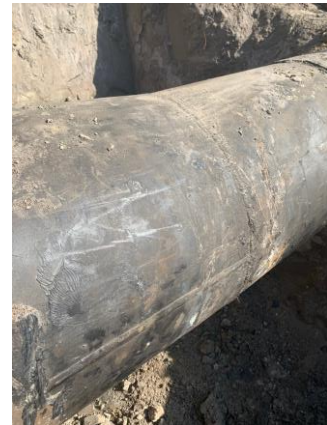
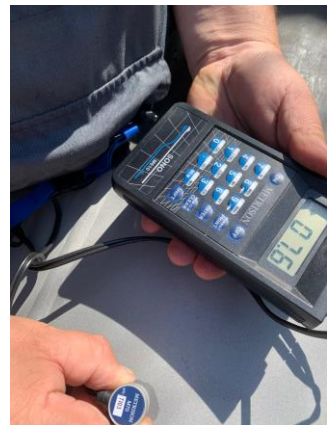
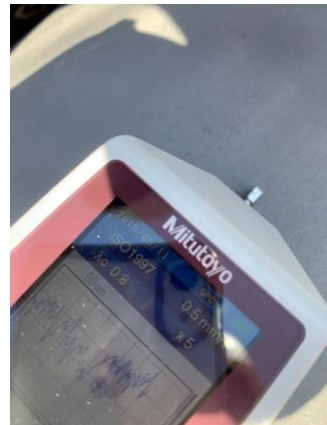
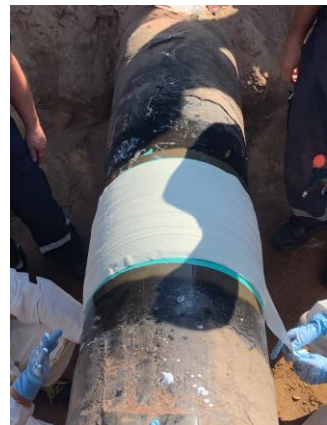
Designing a suitable composite repair involves taking into account the possibility of perforation already occurring after the composite material has been applied. There is also a lack of certainty about how large the defect will be. In the case in issue, the operator of the high-pressure gas network requested the design of a repair muffle for the DN500 mm pipeline, where the design and working pressure was 5.4 MPa

Before applying the composite material, the specialists conducted an additional test of the pipeline wall thickness in the welded joint area using an ultrasonic method. In addition, using a digital meter, the level of surface roughness necessary for the application of the composite material was checked. Next, an epoxy filler, primer and then fiberglass material were used, which was wound over a length of 540 mm in 28 layers.

A team of four technicians, who had previously received training in the application of composite materials in accordance with ISO TS 24817, performed the protection of two welds on the gas pipeline in one working day. Thanks to the efficiently carried out repair, the useful life of the pipeline sections designated for repair has been extended by 50 years.
