REPAIR TECHNOLOGY DEVELOPED BY AN INTERNATIONAL TEAM OF ENGINEERS

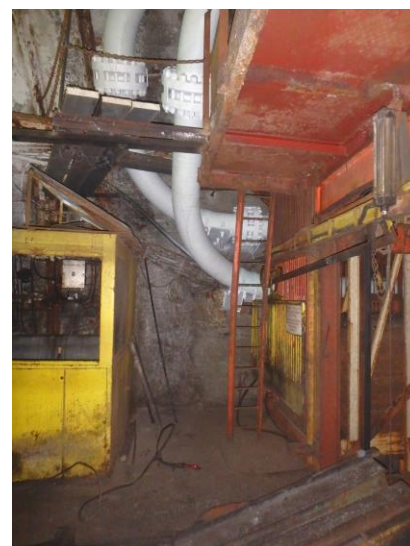
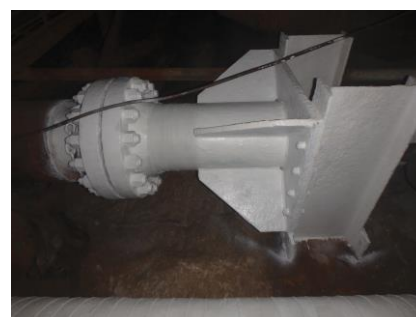
Composite repair material technologies are proving indispensable wherever it is not possible to take a pipeline out of service, or disconnecting it involves significant costs. Repairs with composite materials can be performed on an operating pipeline, regardless of the pressure and what kind of liquid/gas is transmitted through the pipeline. When performing the repair, only the necessary safety measures (personal protective equipment) should be taken care of for those performing the repair. In the presented case, the pipes located in one of the coal mines of the Ostrava-Karviná coalfield transporting cooling water at a working pressure of 110 bar, located at a depth of about 1,000 meters underground, required reinforcement.

The mine engineer in charge of maintenance sent an inquiry about the possibility of repair on the Technical Assessment Form to Gascontrol Polska. Thanks to a quick assessment of the situation by experienced engineers, a positive decision was made on the possibility of repair. Urethane-impregnated and water-activated fiberglass was selected as the material for the repair.

A team of experienced installers, who had experience working at the mine site and had been previously trained in working with composite materials, first performed the surface preparation work and then the primer was applied and the fiberglass material was wound. The efficiently carried out work avoided taking the pipeline out of service and extended its useful life by 20 years.
