### REPAIR TECHNOLOGY DEVELOPED BY AN INTERNATIONAL TEAM OF ENGINEERS

### PROBLEM

### APPLIED SOLUTION

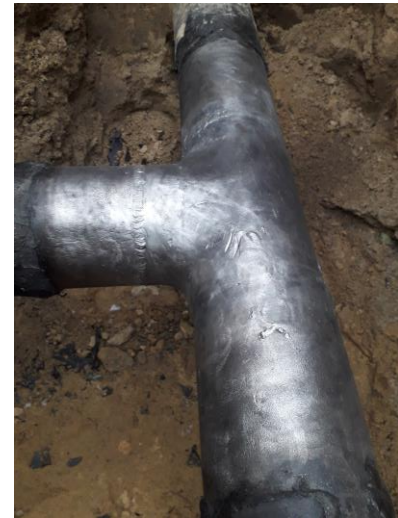
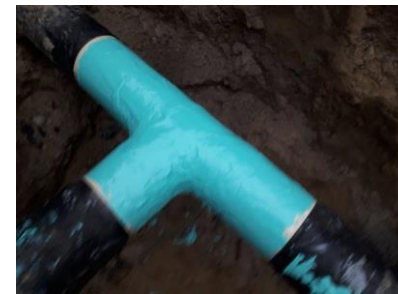
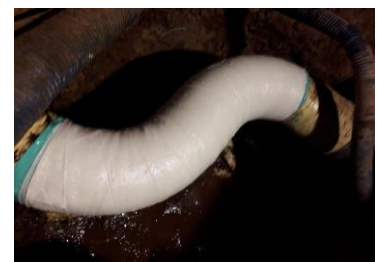
Gascontrol Polska sp. z o.o., thanks to its many years of experience in the use of composite materials, has a large number of weld reinforcement repairs carried out on all types of transmission pipelines in the country and abroad. In order to be able to repair pipelines built before 1990 as well as those newly built, Gascontrol Polska sp. z o.o. has obtained the approval of the Office of Technical Inspection for the repair technology. A fiberglass bandage soaked in urethane was used to make the repair in the case described. The length of the repair and the number of layers were determined based on calculations made by Gascontrol Polska sp. z o.o. engineers. After cleaning the surface, primer was applied to the surface of the tee and then the entire length of the repair was wrapped with composite material.

Thanks to the efficient organization of the work and favorable weather conditions, 12 welded joints were secured in one day. It is worth noting that thanks to its flexibility - composite materials can be used to repair pipeline sections of any geometry.
